Centerboard Pivot Hole Repair

Stuart Richman (June 2005)

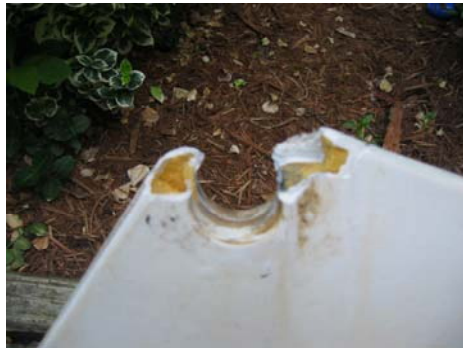
1. Figure 1 shows the damaged area. I first removed the foam core about 1 inch beyond the outer circle of the existing pivot hole. This will open an area to insert layers of fiberglass to repair the broken area and replace the foam core with layers of fiberglass around the pivot hole. This will provide added strength over foam for the core.
