Centerboard Trunk Maintenance/Repair

By Rey Garza

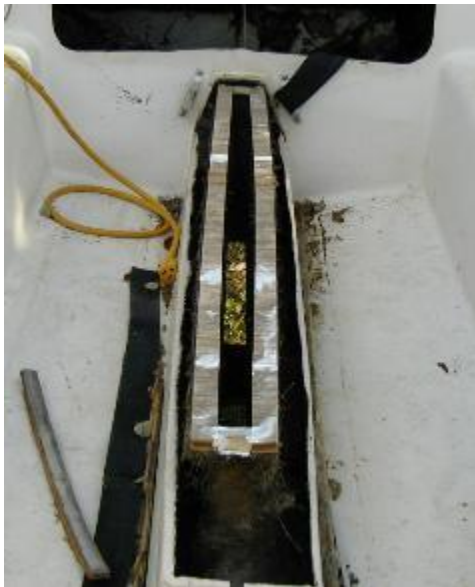
The picture right is what the trunk looked like when I removed the cover. The trunk itself is made of fiberglass, but there are strips of wood that are used for strength, and as an anchor for screws. There is also a strip of foam on top of the wood that serves as a gasket. As you can see on mine the wood had rotted and the foam was dried up and falling apart.

Once the cover was removed, I cleaned off all of the old rotted wood. I replaced it with one inch wide strips of half inch plywood. I used 3M 4200 to secure the plywood strips to the trunk.

Next, I placed a foam strip on top of the wood strips. The material I used was 3/4 inch wide, self adhesive foam that was about 5/16 inch thick.

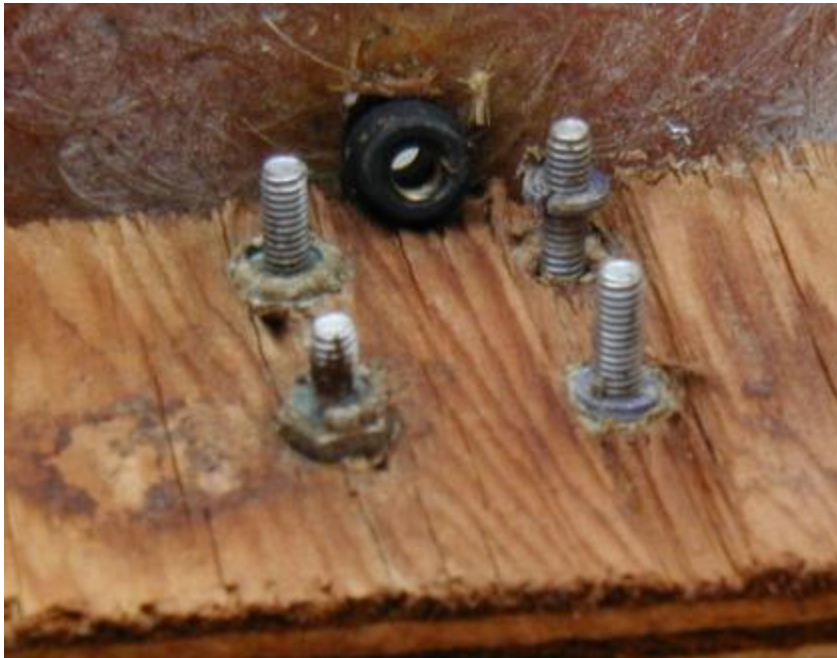
Now for the important stuff. This is a picture of the mainsheet block nuts inside of the trunk cover. (The trunk cover is actually laying upside down in the picture, that's why the bolts are pointing up.) As you can see two of the nuts have corroded away, leaving only the nylon locking portion of the unit. The other two are almost completely corroded as well.
