Safety - Mainsheet Block

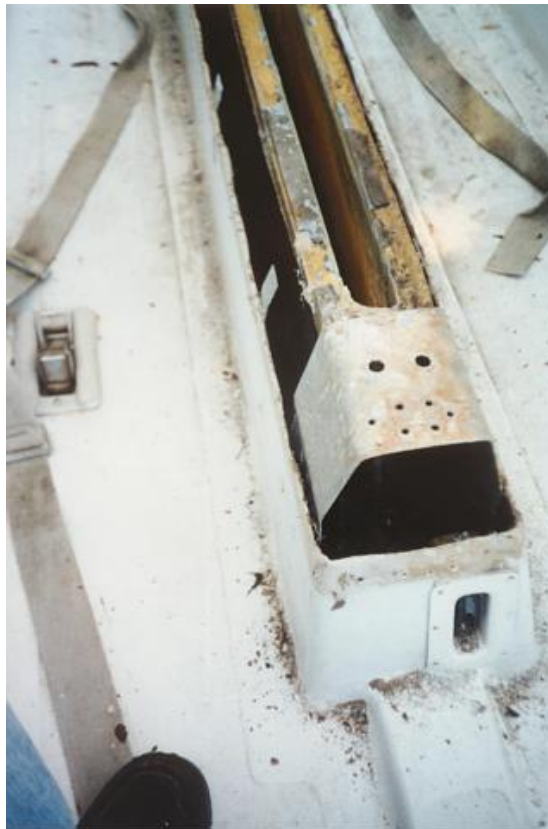
beginning in 1979 Chrysler started installing an aluminum "bridge" to support the rear-most mainsheet block on the rear of the CB cap. Here is a picture of Bob DeRoeck's Mutineer with the CB cap removed showing the aluminum bridge.

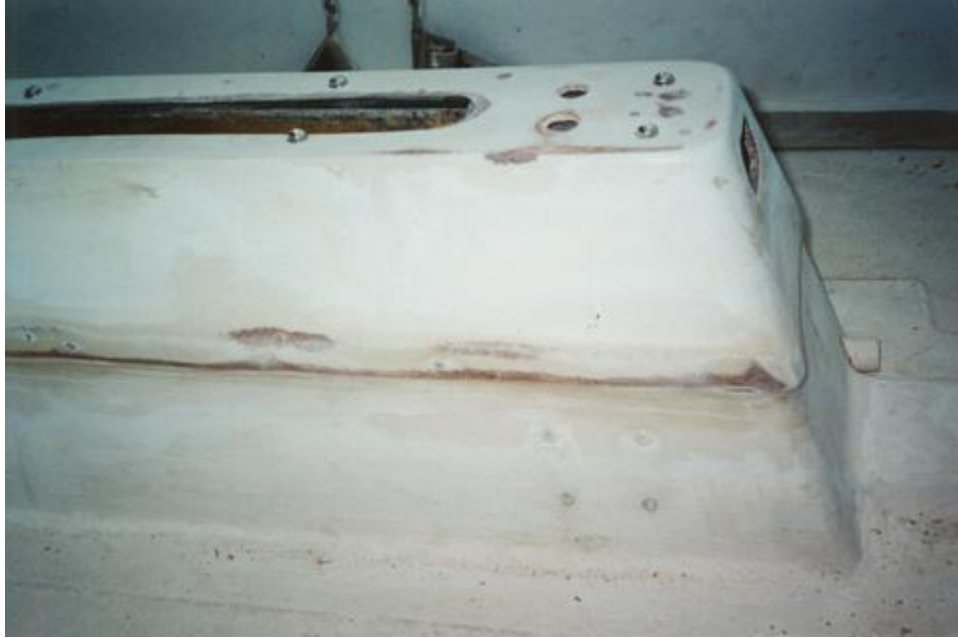
Here is a picture of Bob DeRoecck's Mutineer with an inspection port cut in. Bob used scrap formica to fashion a cover held in place with 2, 1/2" #8 stainless steel self-tapping screws. Be sure to drill 2/32" pilot holes for the screws.

Simply removing the CB cap is not enough to replace the mainsheet bolts and nuts on 1979 and later Chrysler, TMI and Wellcraft Mutineers. You need a way to hold the nuts in place so the bolts can be tightened. An inspection port cut into the end of the CB cap solves this problem.
